Motorcoach and School Bus Fire Safety Analysis

U.S. Department of Transportation
Federal Motor Carrier Safety Administration

November 2016

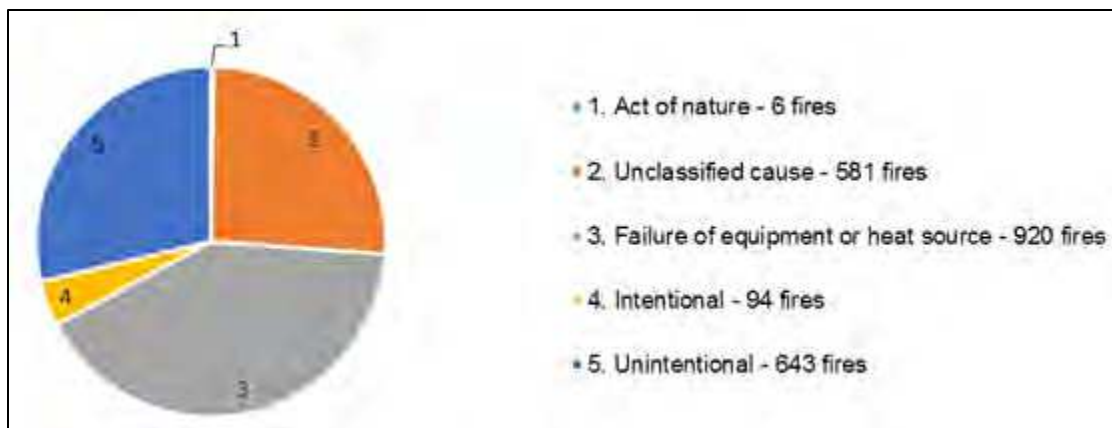
Figure 3 illustrates school bus fires by cause. Similar to motorcoach fires, the majority of school bus fires are caused by failure of equipment or heat source, including mechanical problems. However, school buses have a greater proportion of “intentional” fires. As discussed previously, when school bus fires are broken out by alarm time and cause of ignition (see Table 36 in Appendix Q), most of these intentional school bus fires are shown to have taken place between 3–4 p.m. A number of intentional school bus fires also took place between 10–11 p.m.

Figure 3. Pie chart. School bus fires, 2004–13, by cause of ignition.

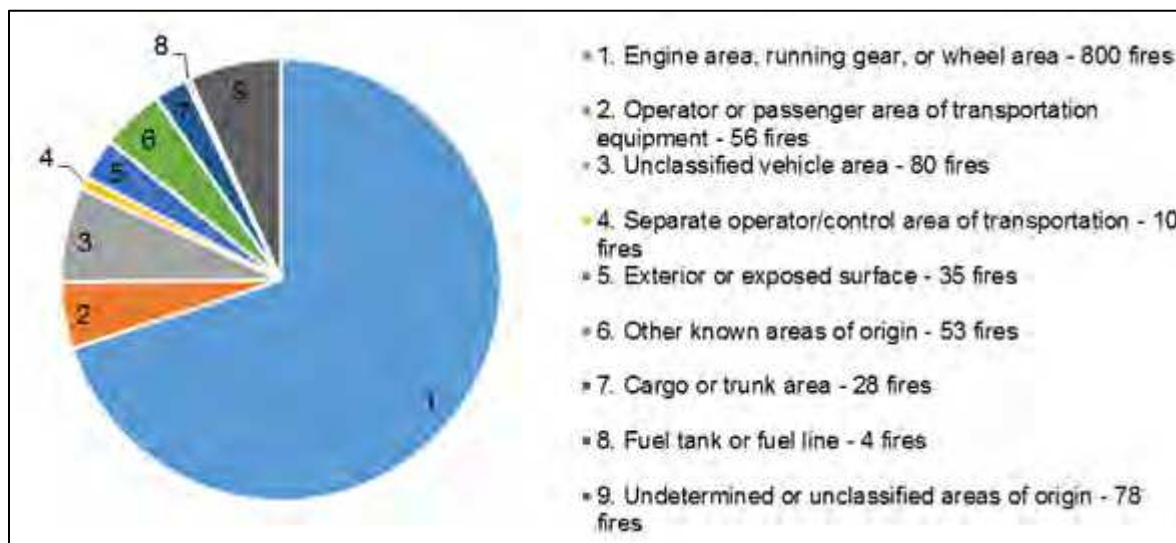
Figure 4 and Figure 5 illustrate the proportions of fires that occurred in various areas. The categories “other known areas of origin” and “undetermined or unclassified areas of origin” specify fires that began outside the vehicle, but it should be noted that most fires originate within the vehicle area. A large majority of motorcoach and school bus fires originate in the engine area, running gear, or wheel area.

Figure 4. Pie chart. Motorcoach fires, 2004–13, by area of origin.

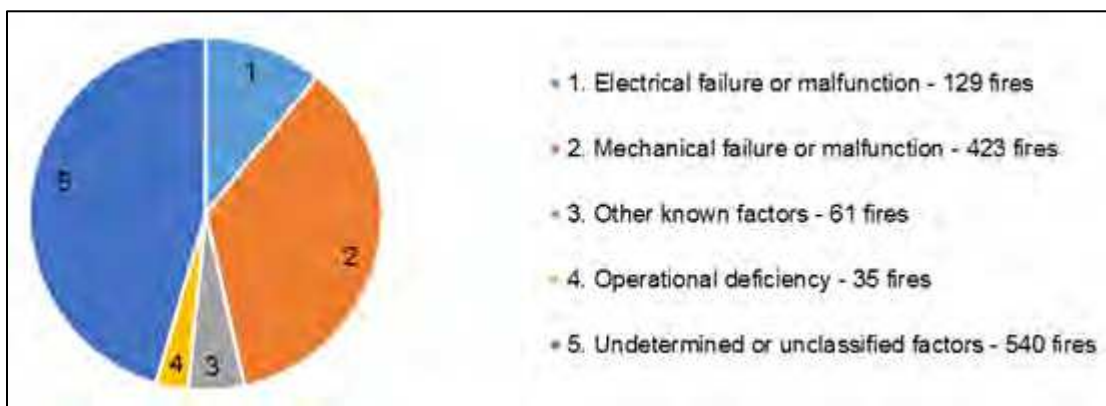
Figure 6 and Figure 7 illustrate motorcoach and school bus fires by factor contributing to ignition. A mechanical failure or malfunction contributed to 48 percent of school bus fires and 65 percent of motorcoach fires where the factor contributing to ignition could be determined. While this percentage for motorcoaches is high, Appendix X shows that motorcoach fires due to mechanical failure or malfunction have been trending down since 2008. An electrical failure or malfunction contributed to 35 percent of school bus fires and 20 percent of motorcoach fires where the factor contributing to ignition could be determined.

Figure 6. Pie chart. Motorcoach fires, 2004–13, by factor contributing to ignition.

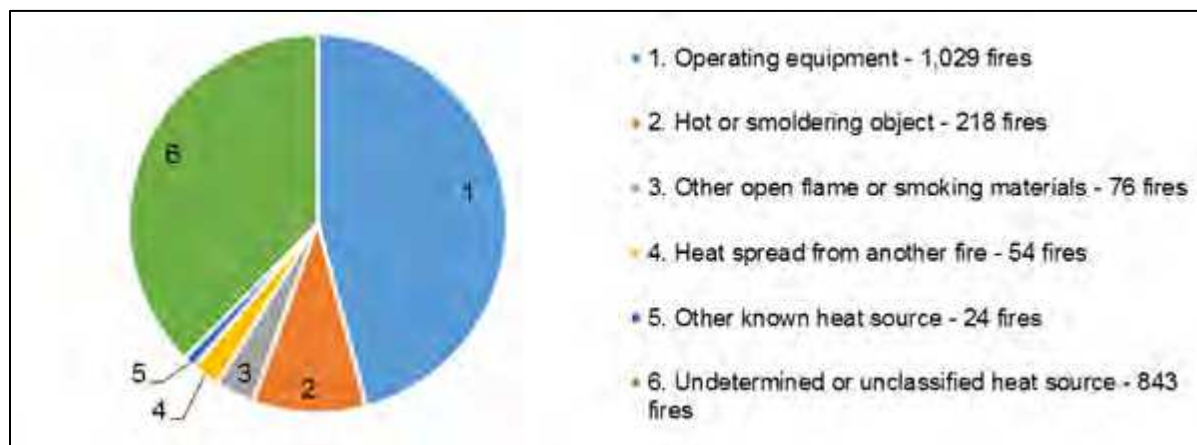
Figure 8 and Figure 9 illustrate motorcoach and school bus fires by heat source. The heat source for 73 percent of school bus fires and 74 percent of motorcoach fires where the heat source was known was the vehicle's operating equipment. The most common values in the operating equipment category are: radiated or conducted heat from the operating equipment; arcing; and a spark, ember, or flame from the operating equipment. The second most common category of heat source for both types of vehicles was a hot or smoldering object, most often heat or a spark from friction. A detailed breakdown of fires by specific heat source is illustrated in Appendix Z.

Figure 9. Pie chart. School bus fires, 2004–13, by heat source.

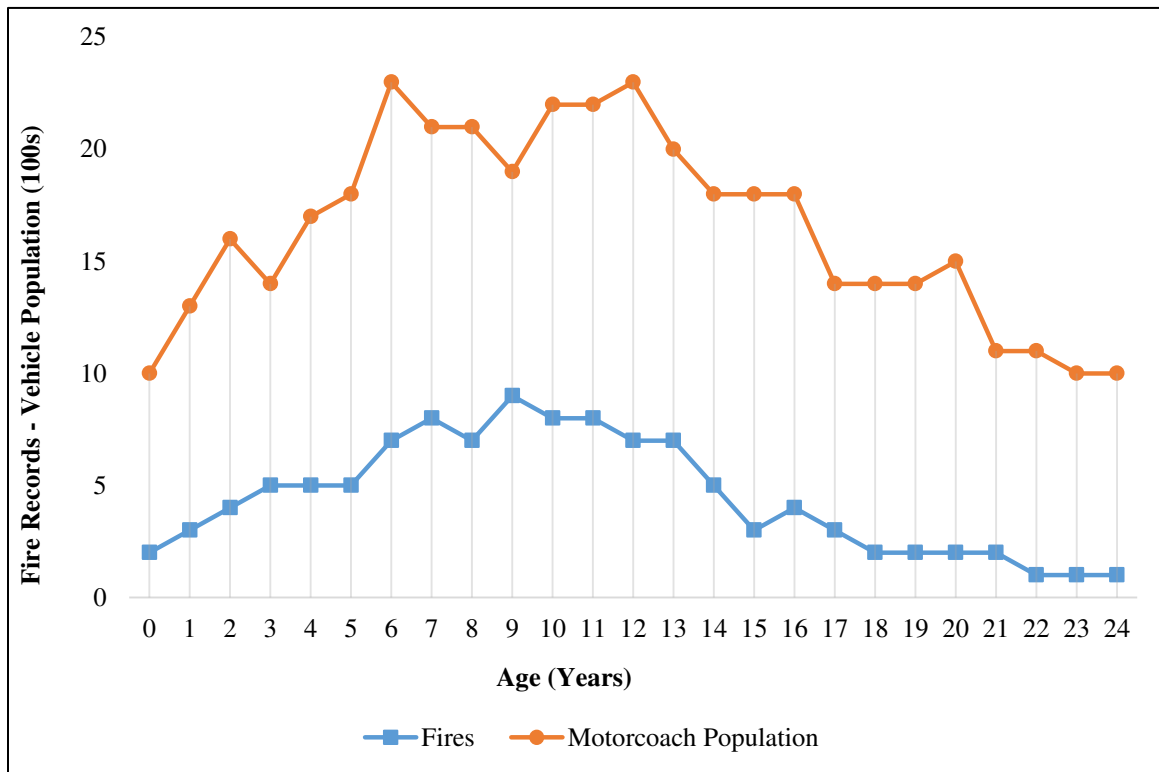
number of motorcoach fires and the ratio of fires to vehicle population are higher for motorcoaches between the ages of 6 and 13 than for any other multi-year age span.

Figure 14. Line graph. Motorcoach fire records and average population, 2004–13, by vehicle age.

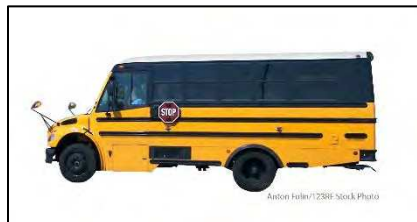
The Type B school bus, shown in Figure 19, consists of a bus body constructed and installed on a front-section vehicle chassis, or stripped chassis, with a GVWR of more than 10,000 pounds. Additional details are as follows:

- Entrance: The entrance door is behind the front wheels.
- Capacity: Designed to carry 10 or more passengers, and can typically seat 30 to 36 passengers.
- Engine: Located in the front of the vehicle. Part of the engine is beneath and/or behind the windshield and beside the driver's seat.

Figure 19. Photograph. Type B school bus.

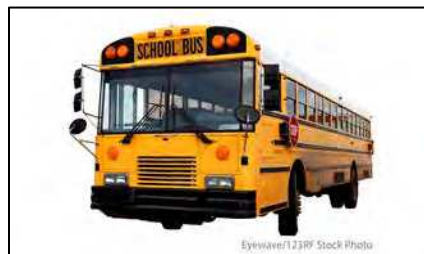
Type D school buses (shown in Figure 21) have a body installed on the chassis with a GVWR of more than 10,000 pounds. This type can be up to 45 feet in length. Additional details are as follows:

- Entrance: The entrance door is ahead of the front wheels.
- Capacity: Designed to carry 10 or more passengers, and can typically seat 54 to 90 passengers.
- Engine: May be located behind the windshield beside the driver's seat; behind the rear wheels; or mid-ship between the front and rear axles.

Figure 21. Photograph. Type D school bus.
